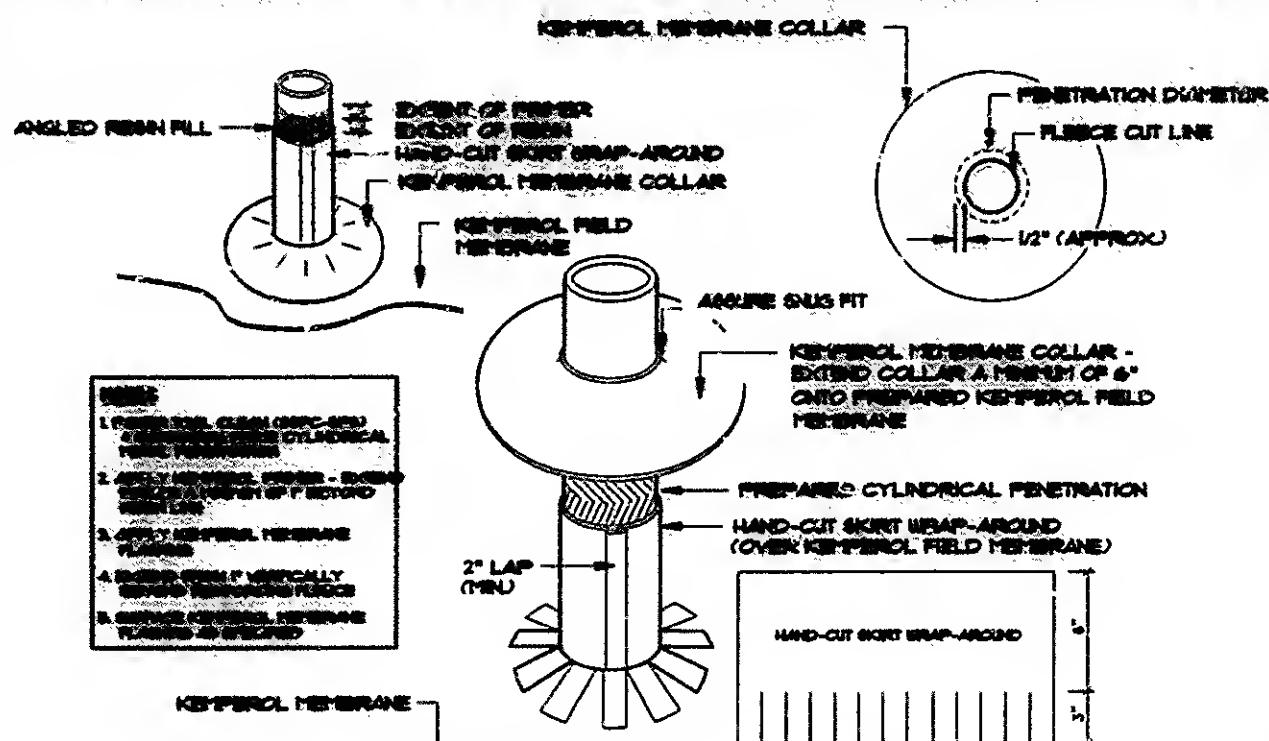
D1 FLASHING AT PIPE PENETRATION
A-3
NOT TO SCALE

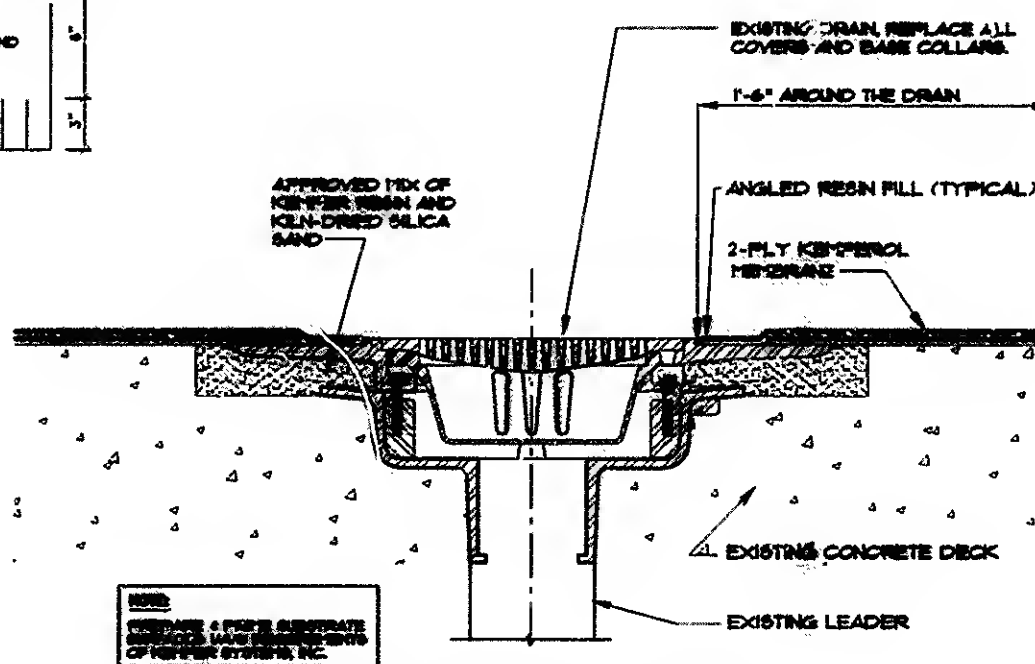
D3 FLASHING - PARK DECK DRAIN (TYPICAL)
A-3
NOT TO SCALE

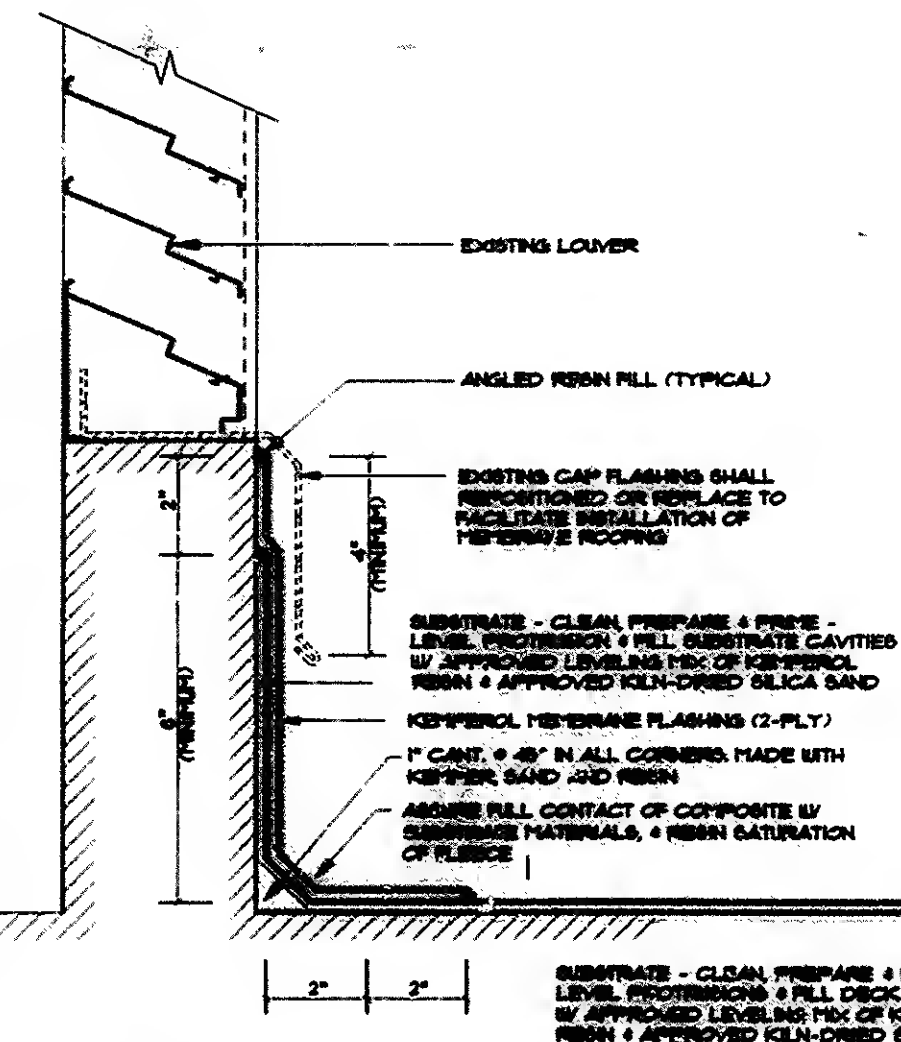
D4 FLASHING AT CURB PENETRATION (TYPICAL)
A-3
NOT TO SCALE

D4a PILLAR DETAIL WITH LOUVER COPING
A-3

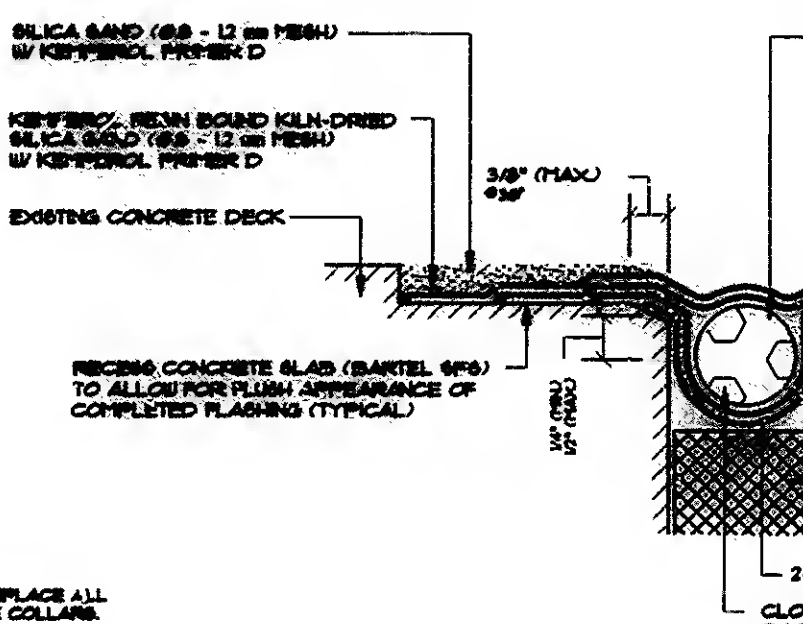
D2 FLASHING - TRAFFIC JOINT (W)
A-3

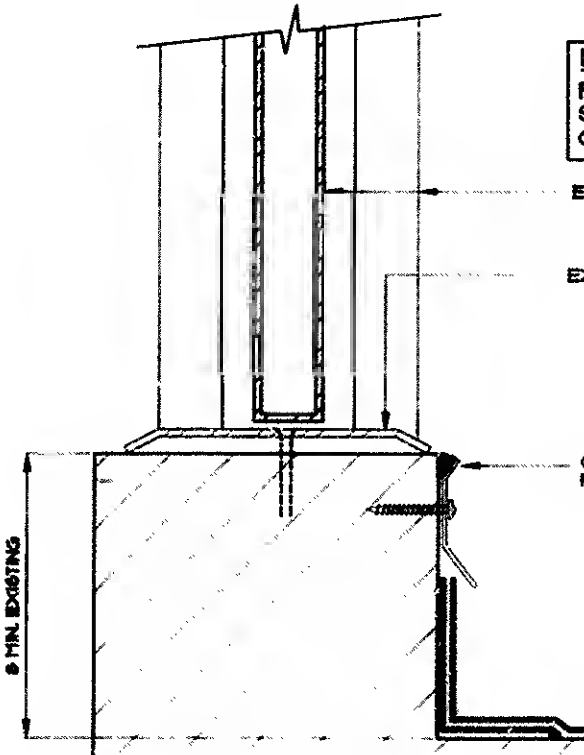
D5 FLASHING - DOOR SILL (TYPICAL)
A-3
